CASE STUDY

Lava Cap Mine Nevada County, California

August 2010

**Prepared by
The Interstate Technology & Regulatory Council
Mining Waste Team**

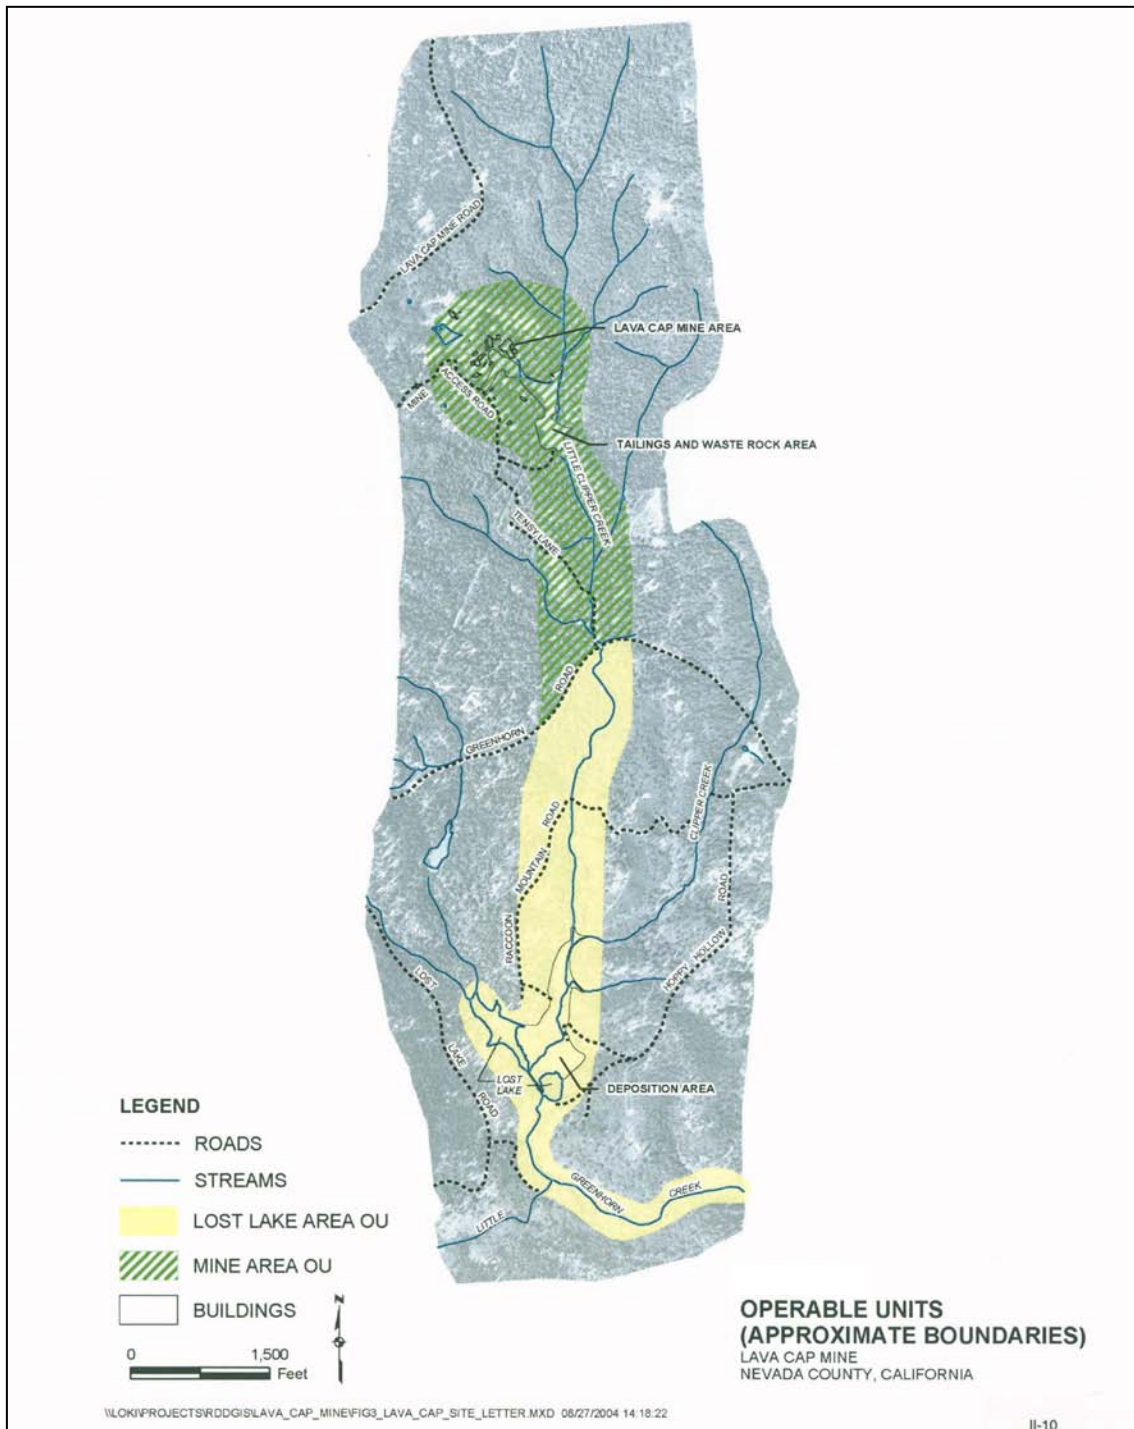
Figure 1-2. Operable units.

Superfund funding to be spent on investigation and cleanup of the site. In 2004, as a result of initial studies of the site, EPA divided site into four project areas, or Operable Units (Figure 1-2).
