## **CASE STUDY**

# **I-99 Remediation Site Centre County, Pennsylvania**

**August 2010**

**Prepared by  
The Interstate Technology & Regulatory Council  
Mining Waste Team**

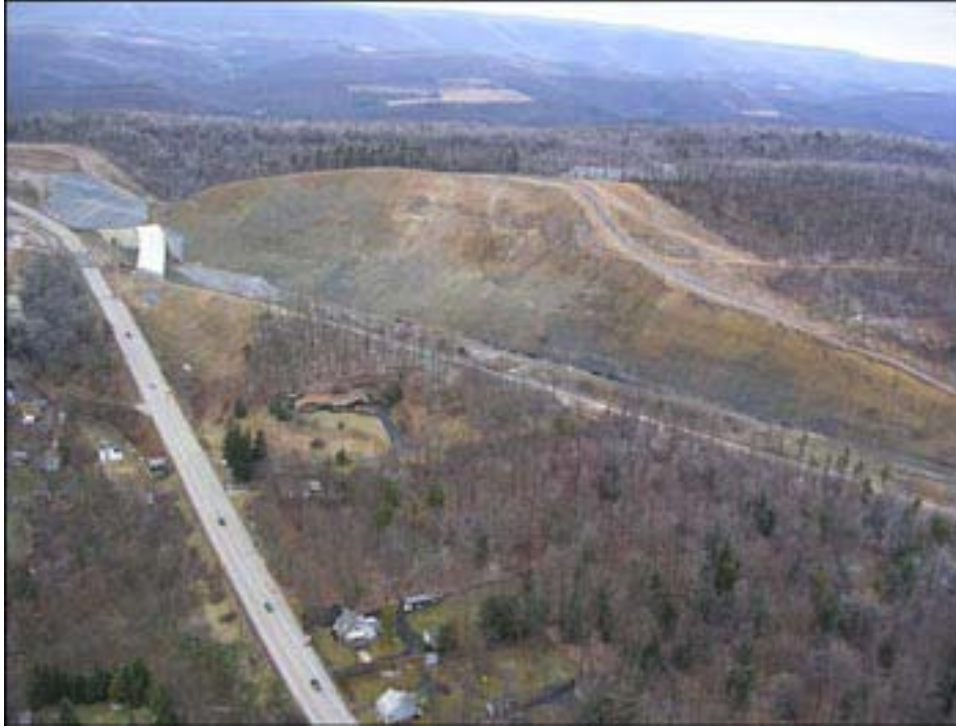
**Figure 1-1. Aerial view of the Skytop cut on January 6, 2005 looking north.** Existing Route 322 in foreground. Future I-99 roadbed runs along the base of the cut. Black plastic covers one of several areas of pyritic fill as a stopgap measure to minimize water infiltration. (Photograph courtesy Keith Brady)
