CASE STUDY

Leviathan Mine Site Alpine County, California

**Prepared by
The Interstate Technology & Regulatory Council
Mine Waste Team**

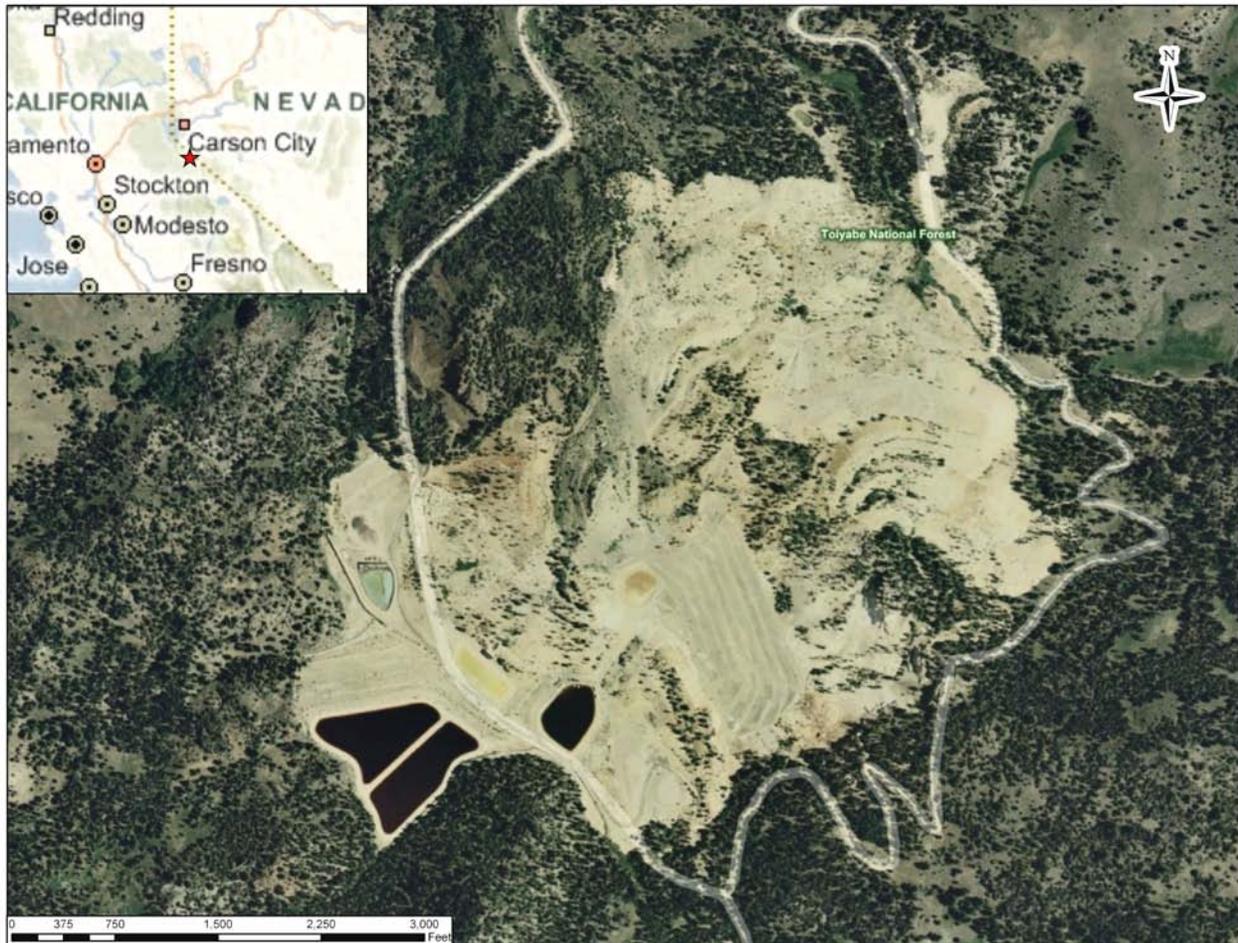
Figure 1-1. Aerial view of the Leviathan Mine.
Created with ESRI ArcView software using Microsoft Bing maps.

The Leviathan Mine is a former sulfur mine that the state of California acquired in the early 1980s to address water quality problems caused by historic mining. The open-pit mine was a source of sulfur from the 1860s to the 1960s and is now inactive. The Leviathan Mine site is at an elevation of 7500 feet above sea level, on the eastern flank of the central Sierra Nevada Mountains in Alpine County, California, approximately 6 miles east of Markleeville, California, and 5 miles west of Topaz Lake, Nevada (Figure 1-1).
