CASE STUDY

Toby Creek Mine Drainage Site Elk County, Pennsylvania

**Prepared by
The Interstate Technology & Regulatory Council
Mining Waste Team**

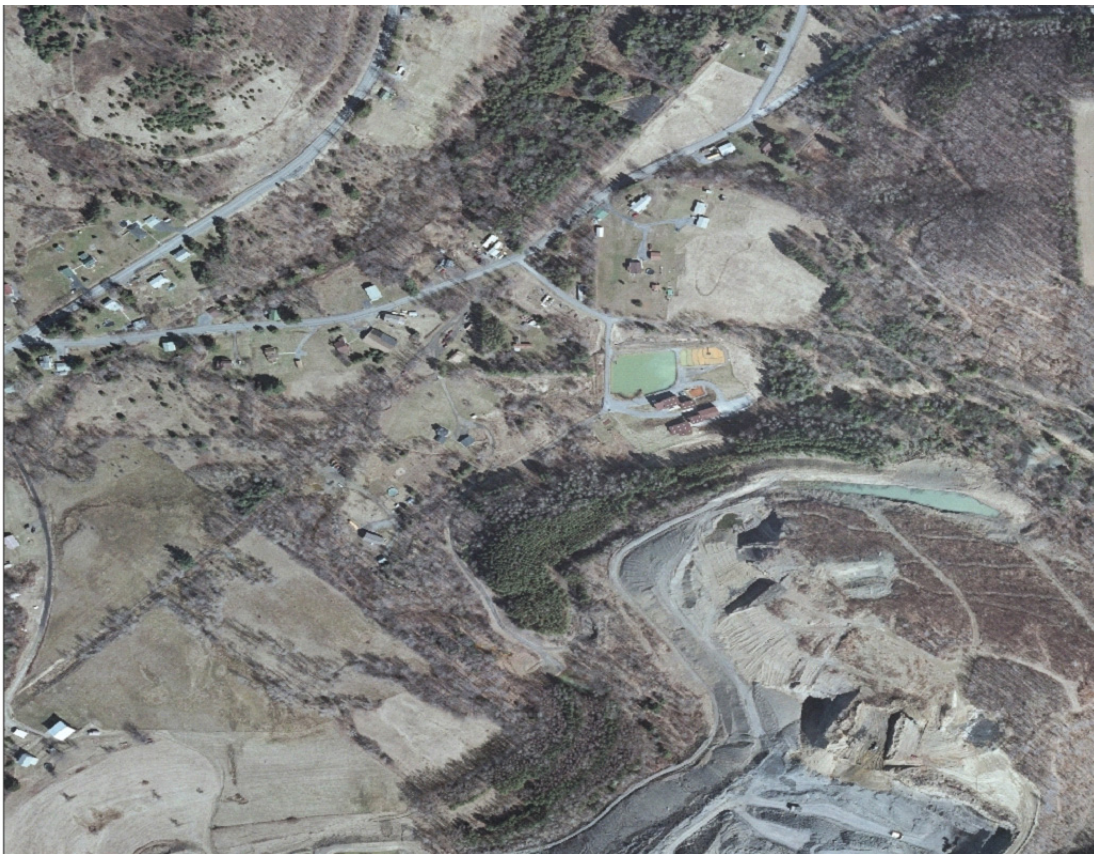
Figure 1-1. Areal view of Toby Cree Mine site. Created with ArcGIS Desktop Version 9.3.1.

The Toby Creek mine drainage site is located in St. Marys, Elk County, Pennsylvania (N 41.32744, W 78.62516, see Figure 1-1). The drainage originates from a coal mine, and impacts nearby surface water. The drainage is characterized by a pH of 3.1 and an acidity of 260 mg/L.
